TRIM—PASSENGER SEAT RUBS AGAINST DOOR PANEL

Article No.
03-1-5

FORD: 1999-2003 MUSTANG

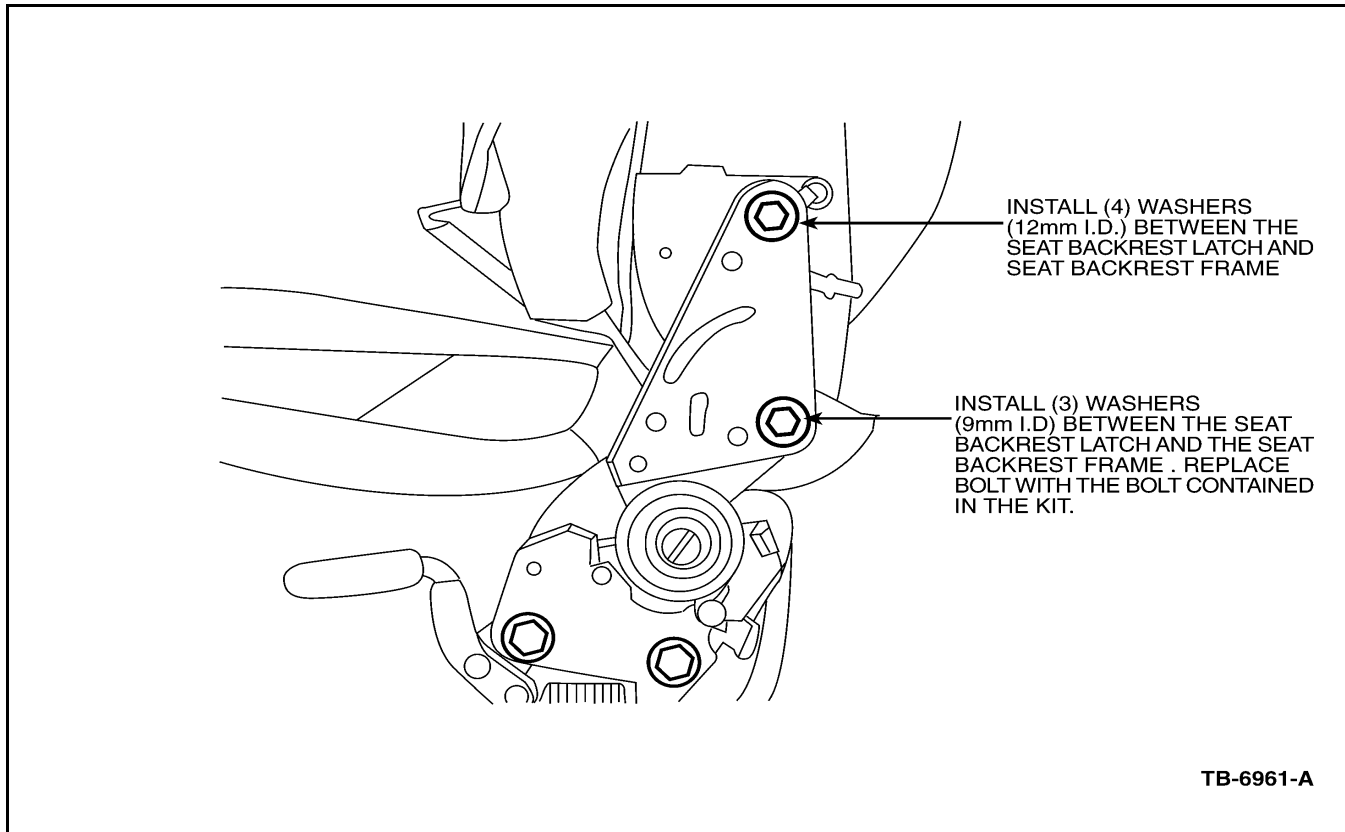
Figure 1 - Article 03-1-5

Some vehicles may exhibit the passenger seat rubbing against the door panel or trim. This may result in a squeak type noise, especially in vehicles equipped with leather seating. This may be caused by the seat position in the vehicle.

1. Remove the front passenger seat per Workshop Manual procedure listed in Section 501-10.
2. Remove the front passenger seat backrest and latch per Workshop Manual procedure listed in Section 501-10. Only remove the top two bolts of latch (Figure 1). Discard lower bolt.

5. Install other four (4) of the 1.5mm-thick washers between the seat backrest latch and the seat backrest frame at the upper bolt location (Figure 1).

6. Install the three (3) 2mm thick washers (smaller I.D.) between the seat backrest latch and the seat backrest frame at the lower bolt location (Figure 1).
